**SITE 031 TRACK 1  
DECISION DOCUMENTATION  
PACKAGE, OU 10-08**

## DECISION DOCUMENTATION PACKAGE COVER SHEET

<b>Site Description:</b>	Two Eight-Inch Diameter Rounds		
<b>Site ID:</b>	031	<b>Operable Unit:</b>	10-08
<b>Waste Area Group:</b>	10

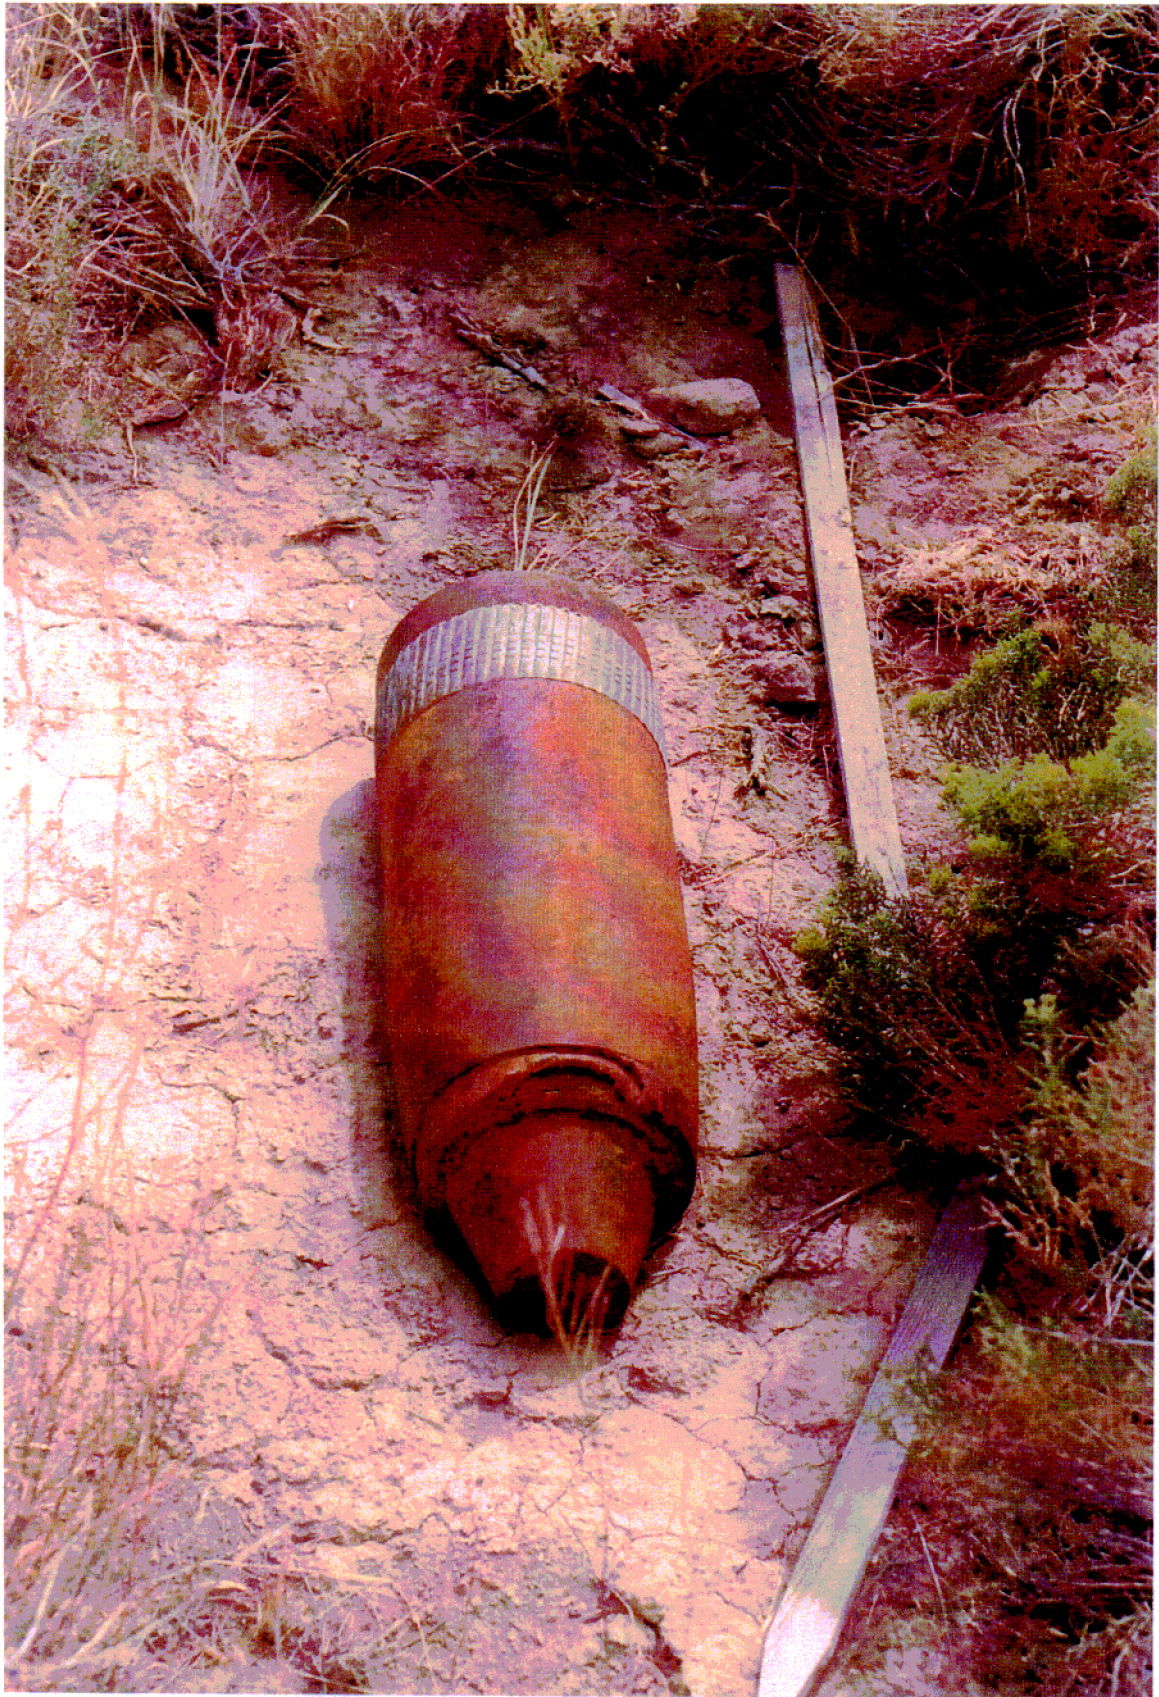
Site: 031 Two 8" Diameter Rounds  
(99-465-2-16)

Site investigations revealed that Site 031 consists of two military rounds likely generated by early naval artillery testing during the 1940s at the INEEL. The two rounds are 1 ft long by 8 in. in diameter, rusted, and weathered. According to the INEEL Environmental Restoration Environmental Safety and Health Quality Assurance (ER ESH&QA) explosives expert, the rounds are inert and pose no risk.

There is no evidence of discolored soil or loss of vegetation near or around the two rounds. There is no visual evidence of hazardous constituents, nor evidence that waste has recently been disposed of at this site. The ground surface shows well established native grasses and sagebrush. The description of the site conditions is based on recent site investigations and interviews; no field screening or sample data exist for this site.

It is recommended that this newly identified site be classified as No Further Action. Field investigations, interviews, historical knowledge of naval artillery testing at the INEEL, and photographs indicate it is highly unlikely that hazardous or radioactive materials were generated or disposed of at this site. It is located on a unmarked road heading northwest from Lincoln Blvd about 7.2 miles northwest of the NRF turnoff. There is nothing present at this site that would indicate evidence of contaminant migration, or historical or threatened release of hazardous substances, pollutants or contaminants. The rounds are inert and pose no risk to human health or the environment.
